**FLIGHT SERVICE EVALUATION
OF COMPOSITE COMPONENTS ON THE
BELL HELICOPTER MODEL 206L**

**SECOND ANNUAL FLIGHT SERVICE REPORT
AUGUST 1983 THROUGH DECEMBER 1985**

**BELL HELICOPTER TEXTRON, INC.
FORT WORTH, TEXAS 76101**

**CONTRACT NAS1-15279
AUGUST 1986**

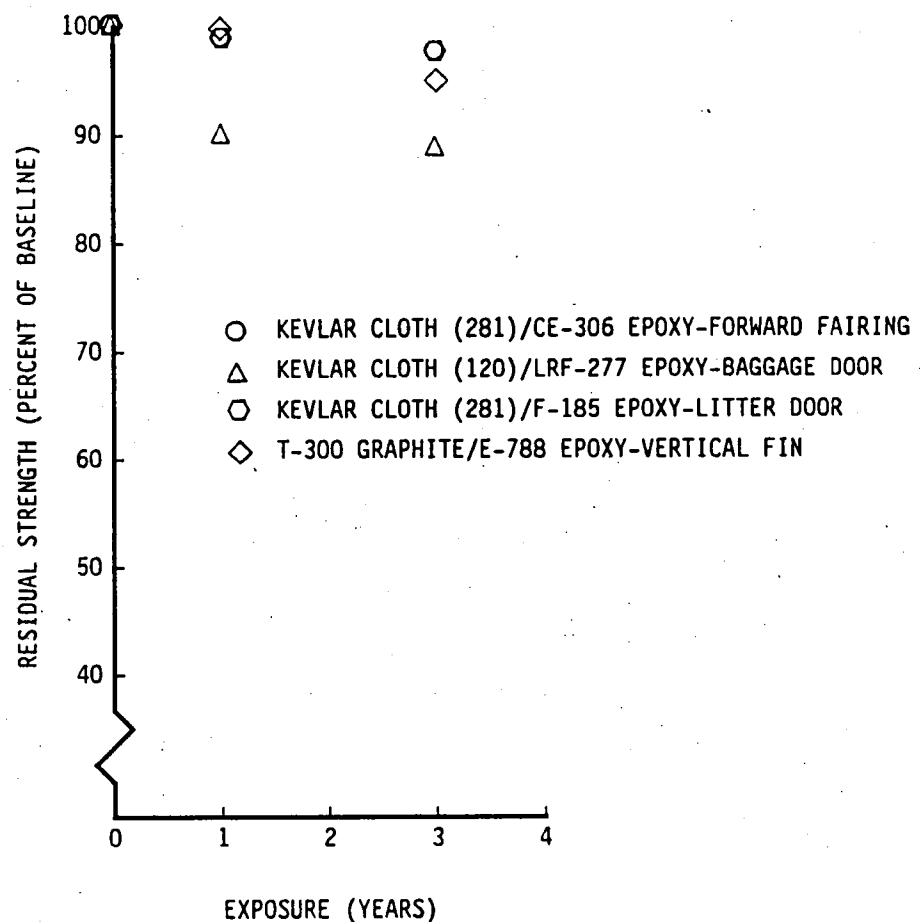
Figure 3-4. Average residual compression strength for painted specimens after three years of exposure.

The average residual compression strengths for painted specimens after three years of exposure are shown in Figure 3-4. Data from all five geographic locations are averaged and presented as a percentage of the baseline strength. All the material systems exhibit fairly good strength retention in compression. The Kevlar-49/LRF-277 (baggage door) had the greatest strength degradation. Its strength retention was 88% of the baseline after three years of exposure. The effects of environment on the residual compression strength for each material are shown in Figures 3-5 through 3-8. The data represent a comparison of the average compression strength after exposure as compared to the average baseline strength for each laminate.

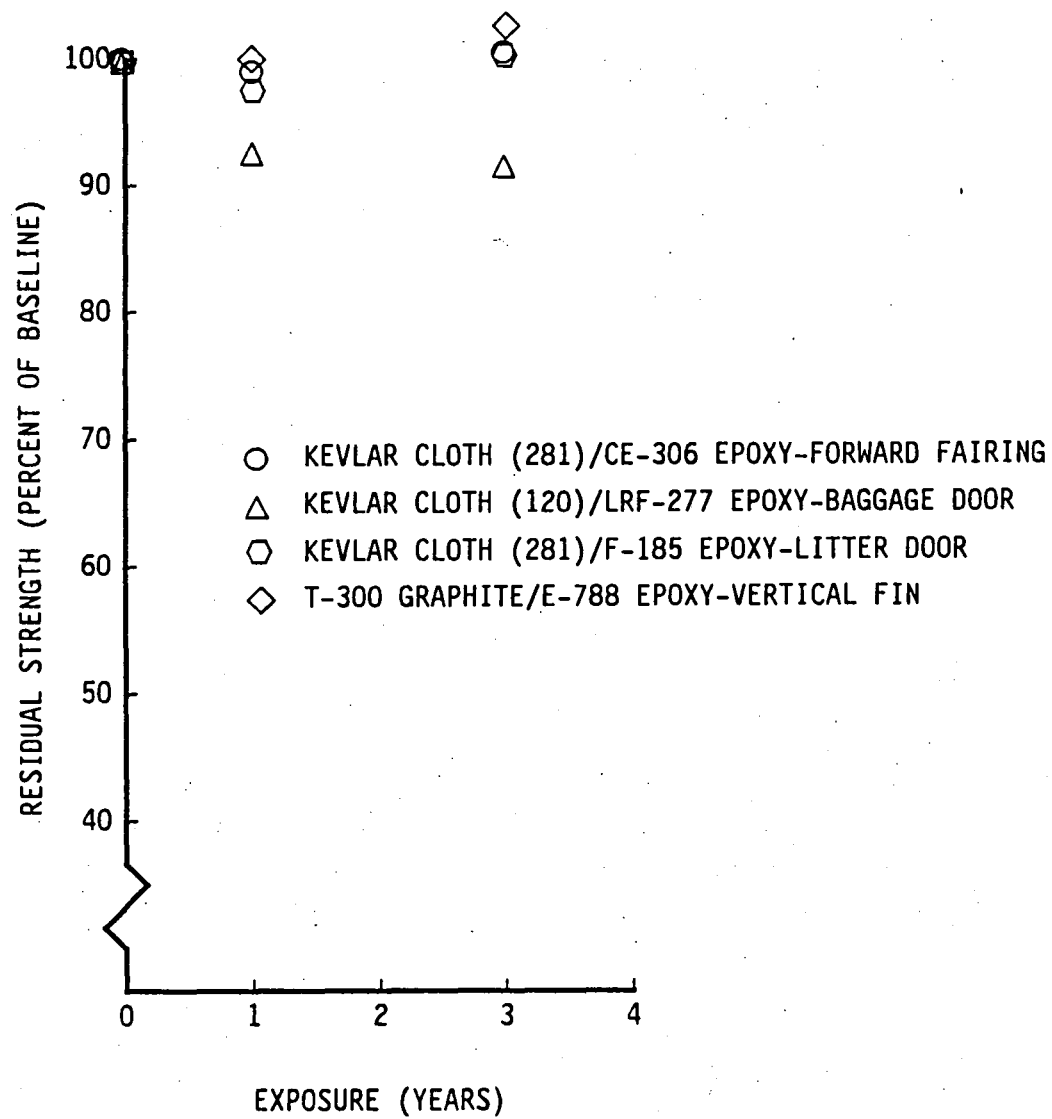
Figure 3-9. Average residual short beam shear strength data.

The average residual short beam shear strength data for the painted specimens with three years of exposure are shown in Figure 3-9. The Kevlar-49/LRF-277 (baggage door) had the lowest short beam shear strength retention. It was

91% after three years of exposure. The other laminates have a residual strength greater than 95% of baseline. The effects of the environments are given in Figures 3-10 through 3-13.

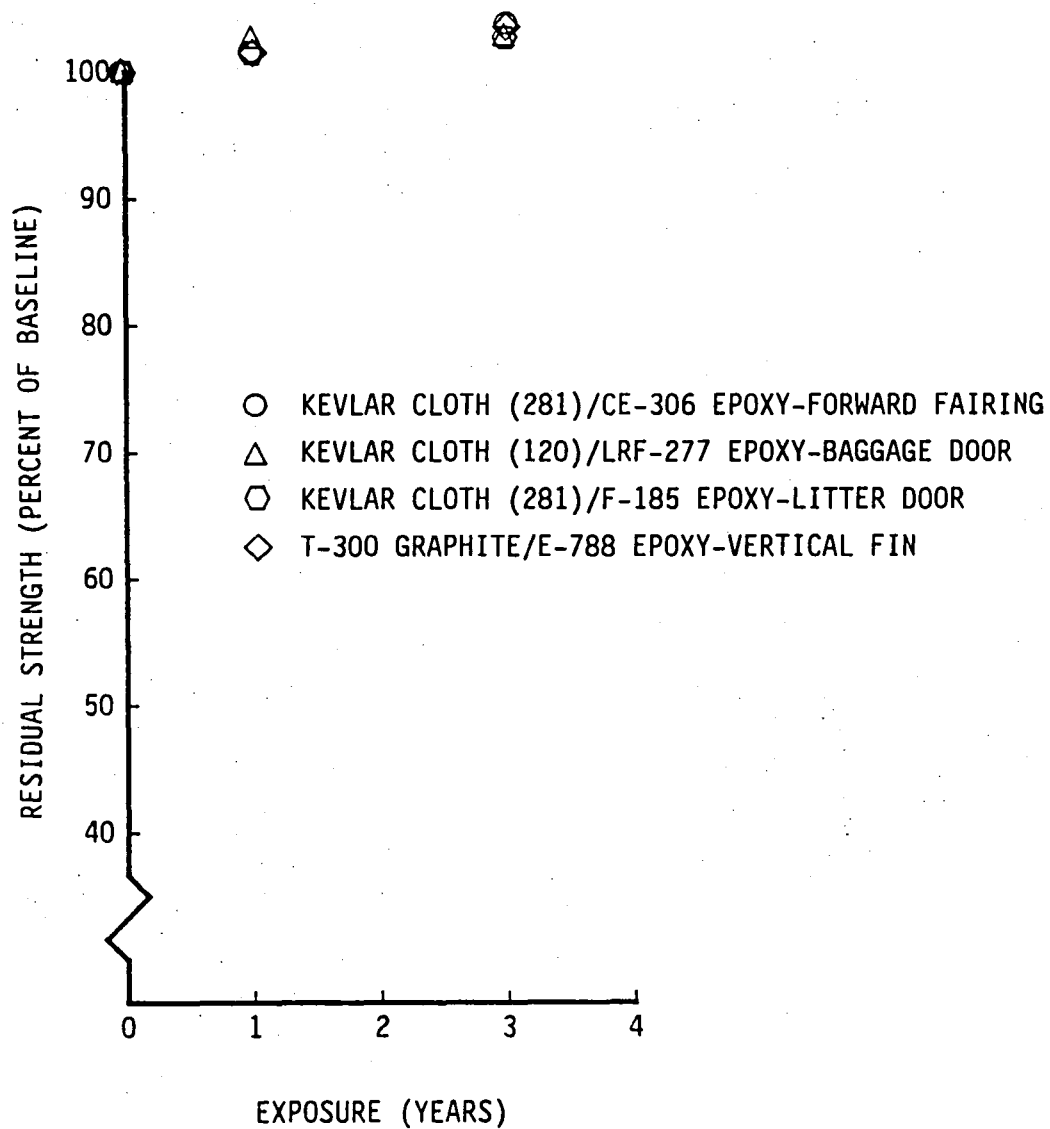
Figure 3-14. Average residual strength for tension coupons.

The tension specimen did not show any significant reduction in strength from three years of exposure. Figure 3-14 shows the average residual strength for the tension coupons. The effects of the environments are given in Figures 3-15 through 3-18.

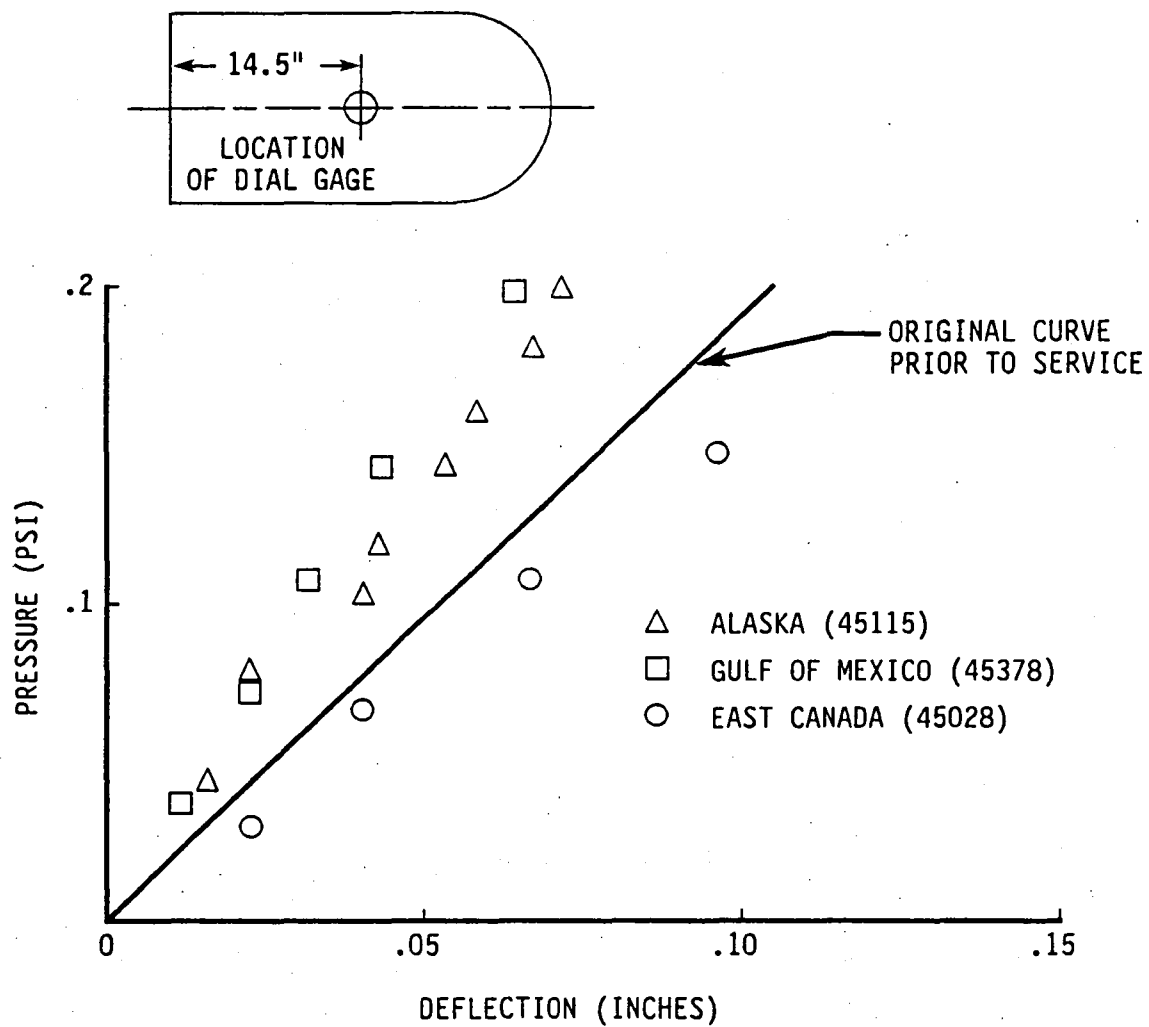
Figure 4-1. Load deflection curve of forward fairing after three years of service.

The deflection for the forward fairing was measured in the center of the fairing, 14.5 inches forward of the back of the fairing. The load deflection data is given in Figure 4-1. The solid curve was developed at the time of certification, prior to service. The current results are given as the symbolized points.

The test was conducted by sealing the fairing in an aluminum box and drawing a vacuum. It was very hard maintaining dimensional stability of the deflection gage during the test. This is the reason for the test of the East Canada fairing being softer than the other parts. Failure occurred when a crack began at the aft latch locations then propagated forward parallel to the edge of the fairing. This failure mode was consistent in all tests.

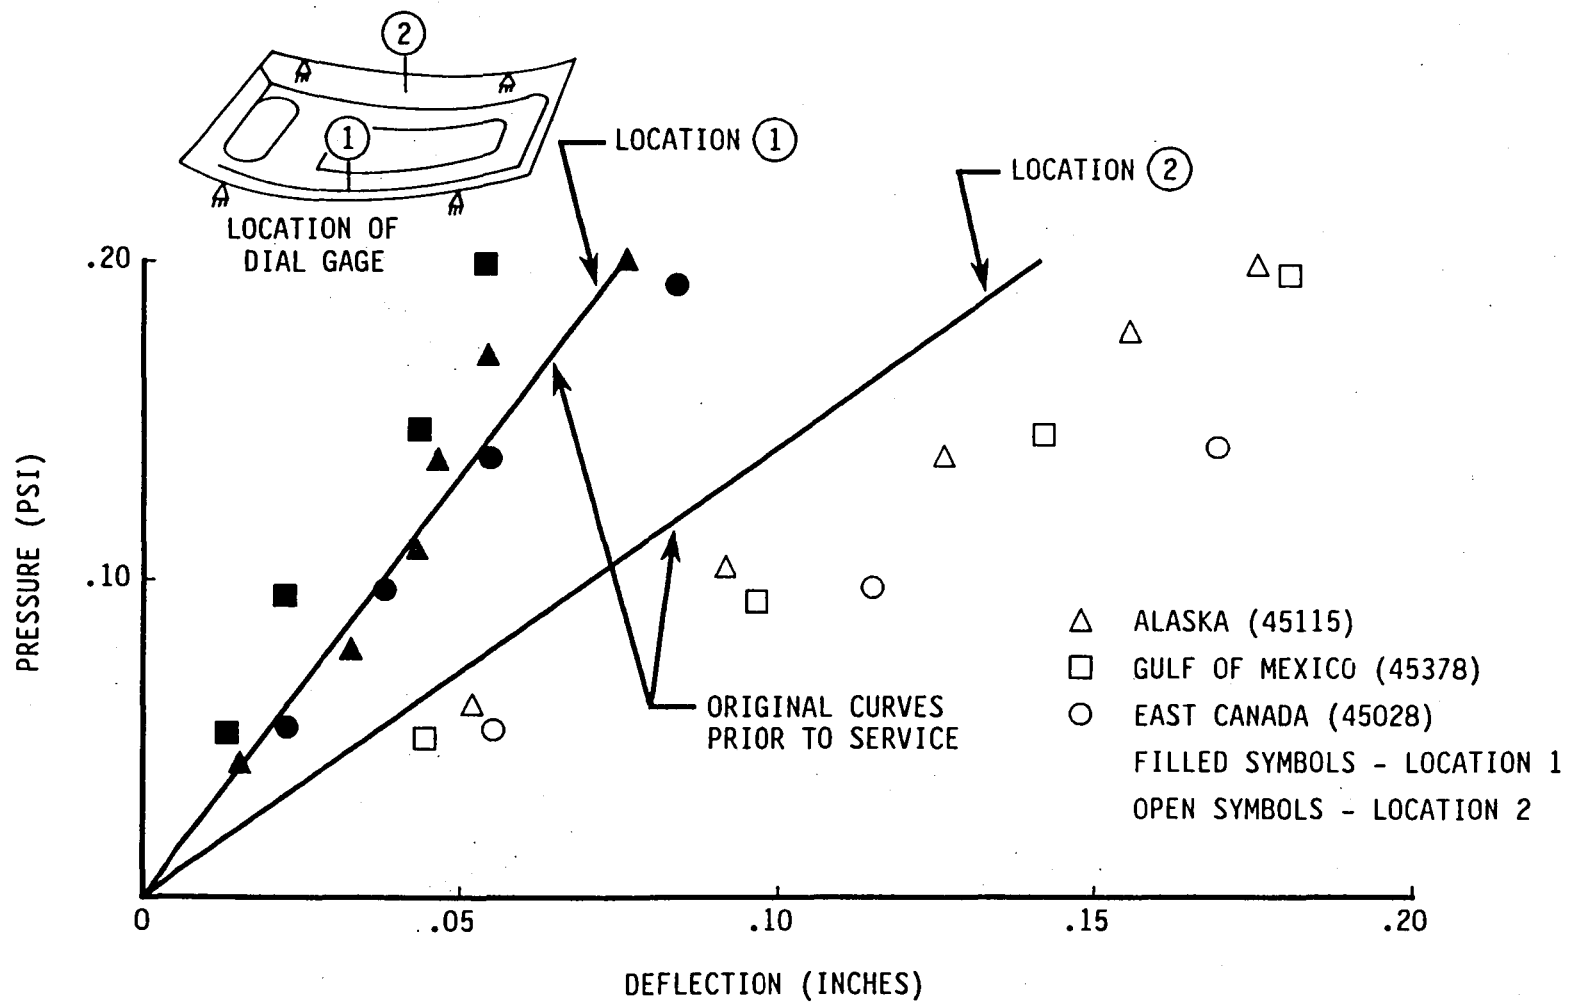
Figure 4-2. Load deflection curve of litter door after three years of service.

Deflections were taken at two locations for the litter door. The locations are shown in Figure 4-2. Location one data tracks the original curve while location two (the larger post) shows a softening of the door. The load deflection curves are given in Figure 4-2. The litter door failure was initiated on the major door post failing as a simply supported beam. After the post breaks, the entire door folds in the middle. This failure was characteristic in all tests.

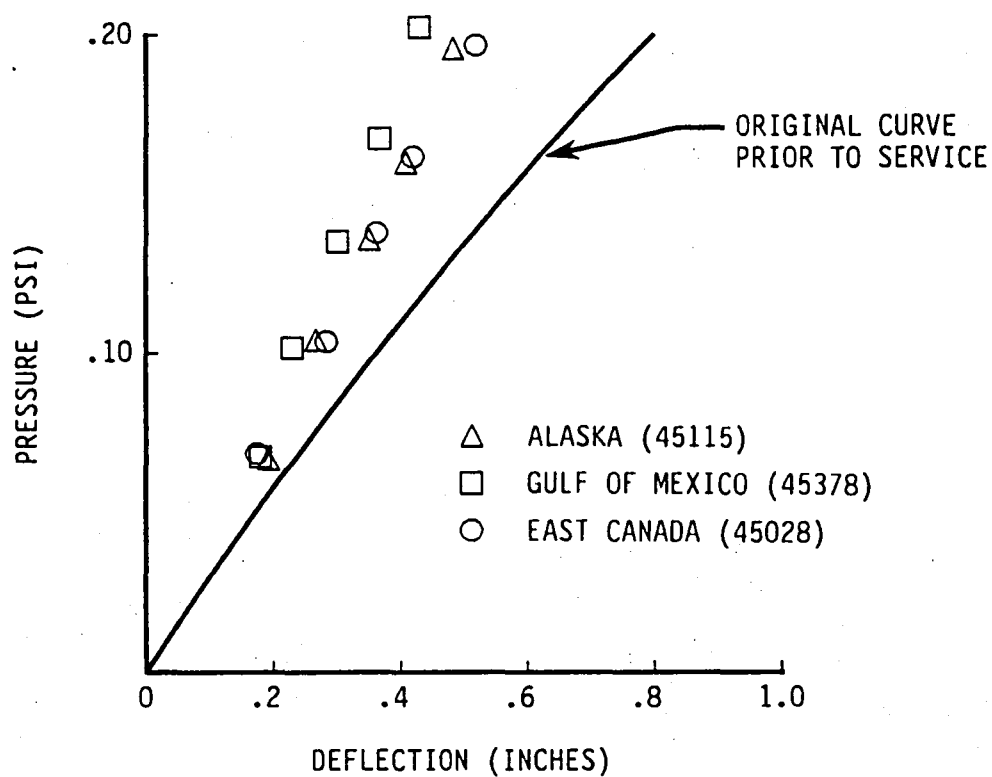
Figure 4-3. Load deflection curve of baggage door after three years of service.

All tests of the baggage door failed as a simply supported beam, folding in the middle, where the moment is the highest. The deflection data for the baggage door was measured in the geometric center of the door. All three geographic areas plot within a tight scatter. They show a stiffening of the door. Examination of the material of the door shows an "evaporation" of the resin thus yielding a stiffening of the door. The load deflection curve of the baggage door is given in Figure 4-3.

The increased strength of the composite baggage door follows the trend of the deflection test where its stiffness increased 60%. The resin had dried out resulting in a much more brittle laminate. It should be noted that while the strength and stiffness of the baggage door has increased, its service behavior was the worst, primarily due to the large void areas and brittleness of the laminate.

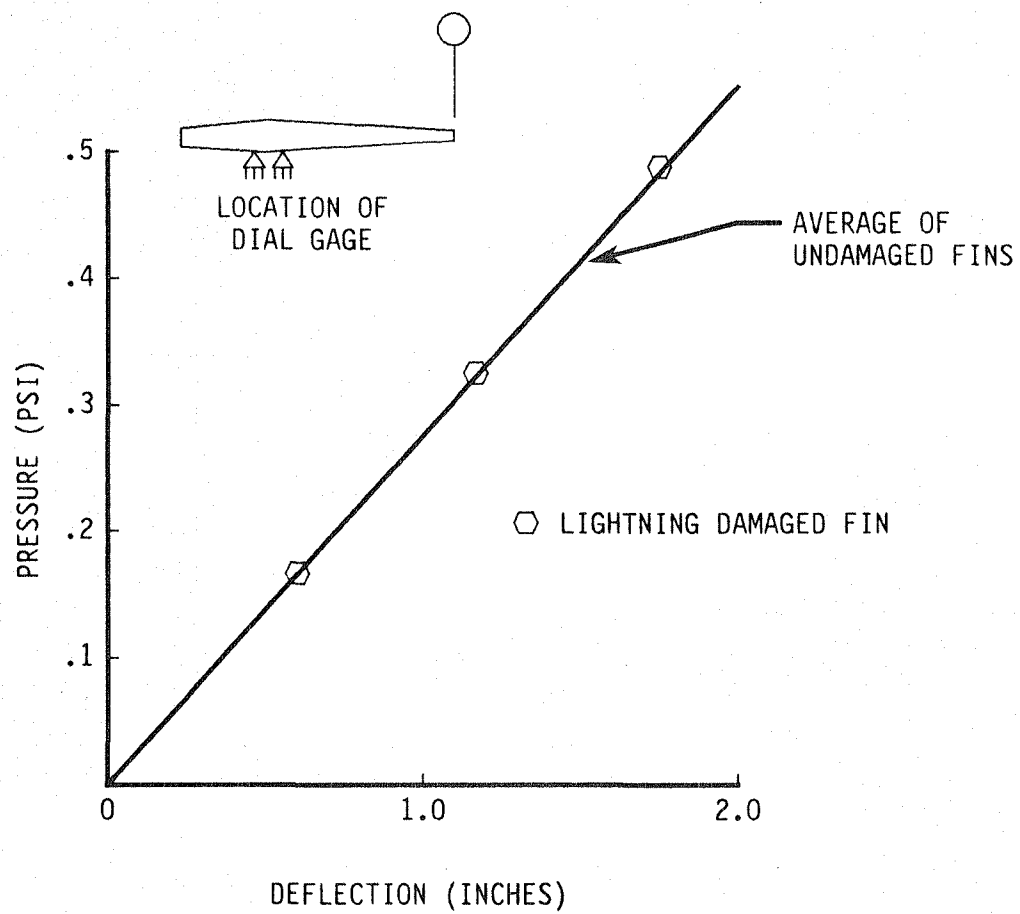
Figure 5-4. Deflection of the lightning damaged fin.

As reported in Section 4, the lightning damaged fin showed no effects on its stiffness or strength. Figure 5-4 shows the deflection measurements compared with the average of the other fins.

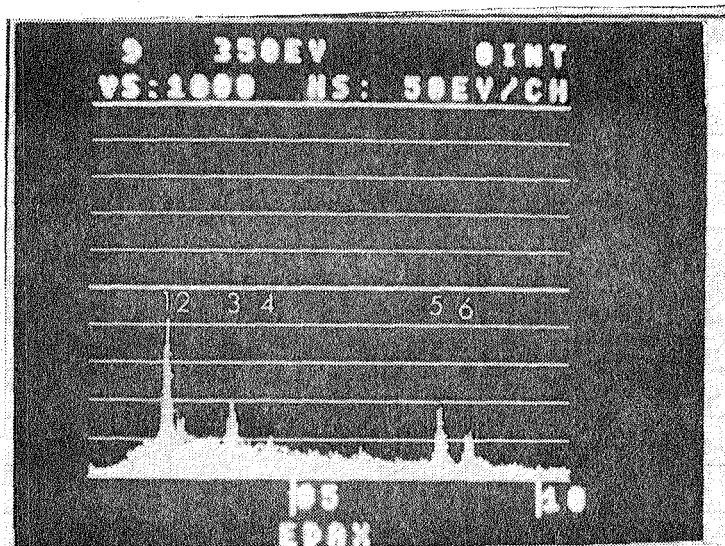
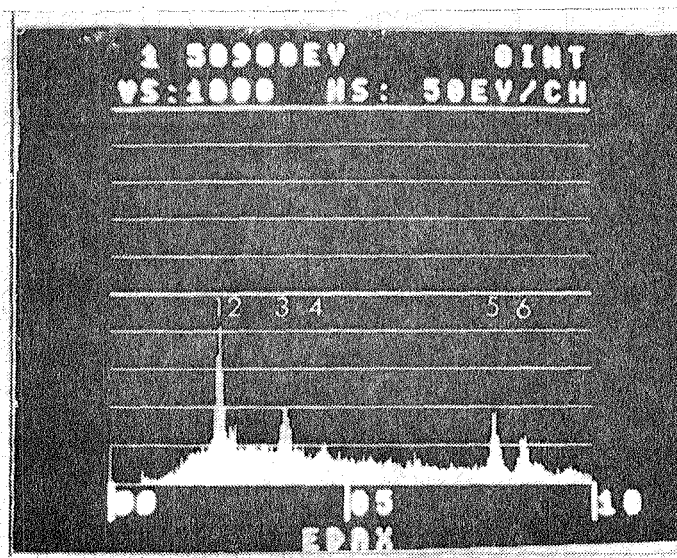
Figure 5-5. Results of EdaX scan on the damaged and undamaged specimen.

The effects of the lightning strike on the graphite was studied using an energy dispersive x-ray analyser (EdaX). Figure 5-5 shows the results of the EdaX scan on the damaged and undamaged specimen. Based on the EdaX results in Table 5-2, there is no basic difference in material.

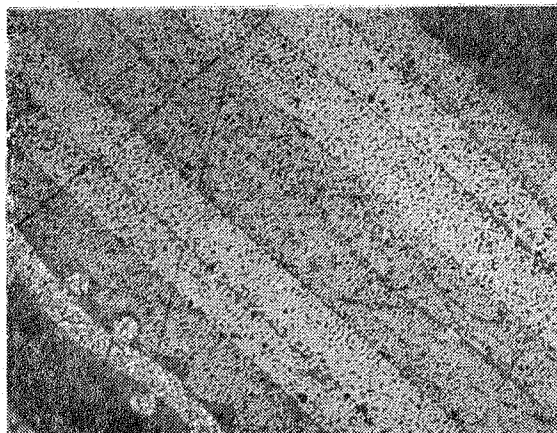
Figure 5-6. 100X magnification of a cross section of the damaged and undamaged specimen.

Tests were conducted on an area six inches down from the top of the vertical fin and three-quarters of an inch up from the trailing edge. The tests concluded the area received a high heat, based on the heavy blistering of the paint finish. The area also exhibited heavy corrosion due to the aluminum wire mesh (lightning protection) being applied directly to the graphite laminate. There was a design error. A layer of FM1000 adhesive was

to separate the wire mesh and the graphite. Instead, the adhesive was applied on the outside of the mesh between the mesh and the paint. Had the FM1000 been correctly applied, the corrosion might not have occurred and the fin could have been easily repaired.

Figure 5-6 shows a 100X photograph of a cross section of the damaged and undamaged laminate. The laminates were of a different orientation and number of plys. The only degradation noticable on the photographs is the wire mesh which had corroded.
